**Appendix D**  
**Mechanical and Electrical Report**  
**Princeton Engineering Group, LLC**

**First Unitarian Society of Plainfield**  
**Mechanical and Electrical Systems**

Preservation Plan for The First Unitarian Society of Plainfield  
Princeton Engineering Group, LLC

February 24<sup>th</sup> 2008  
Appendix D– Page 14

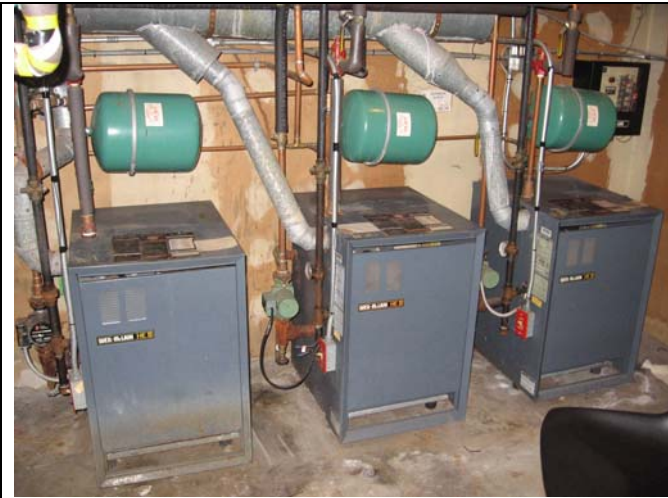
Heating- The building is heated by four gas fired boilers, located in the basement of the school wing (*Fig. H-1*). Distribution is by a primary/secondary pumped hydronic system. There are nine secondary pumps (*Fig. H-2*). The boiler is vented into a masonry chimney.

Heating- The hydronic boilers are approximately 20 years old and appear to be in good condition. The system was said to experience occasional flame failures due to faulty igniters and draft inducer, but this is said to have been corrected.

Fig. H-1- Hydronic boilers.

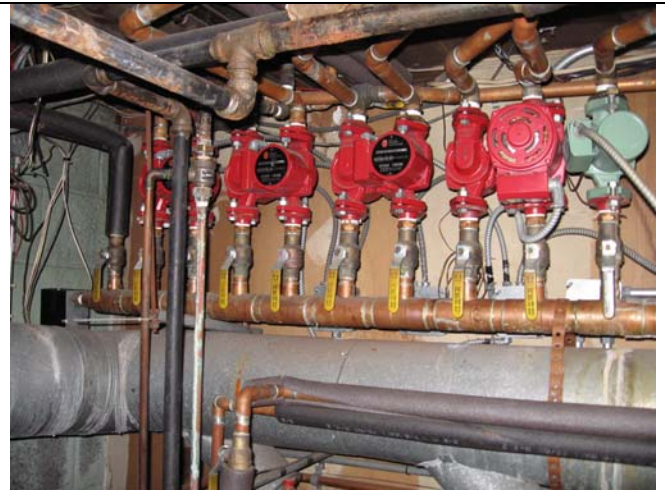
Fig. H-2- Circulating pumps

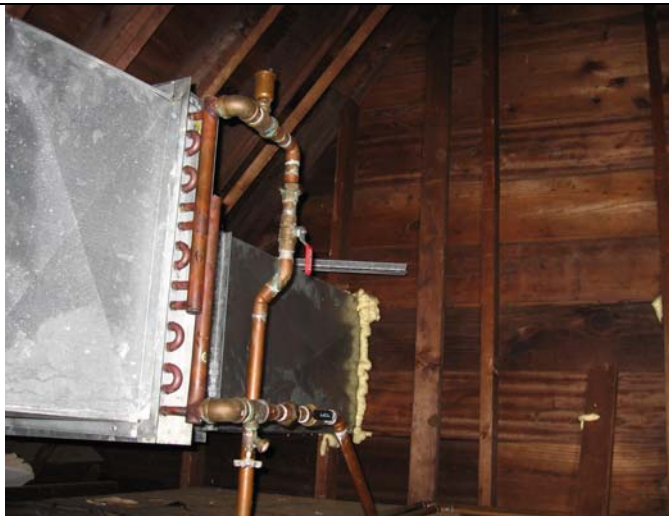
The main circulating pump and the secondary pumps are located in the same boiler room. Terminal devices are largely cast iron baseboard in the school wing. Heating in the Parish Hall is by two hydronic coils in the ductwork serving the space (*Fig. H-3*). There is also a steam boiler located in the Sanctuary basement (*Fig. H-4*) which serves steam radiators (*Fig. H-5*) in the Parish Hall. This system is used as backup if the main system is non-operational.

Fig. H-3- Parish Hall heating coils

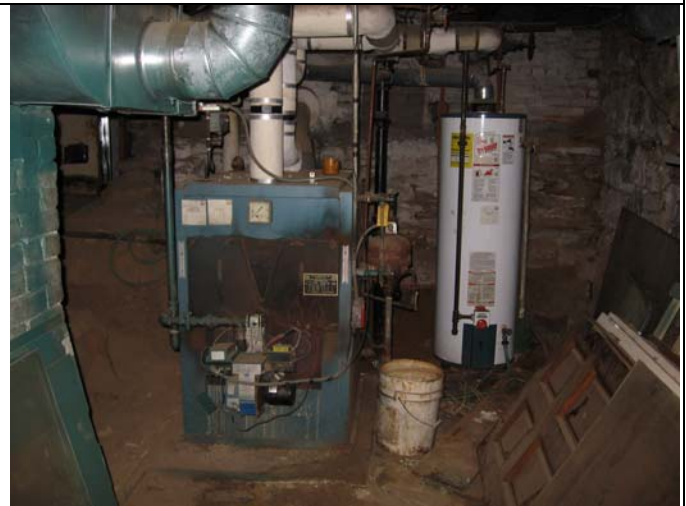
Fig. H-4- Steam boiler

If the main heating system would be made more reliable, the steam radiators and boiler can be removed, reducing the maintenance burden.

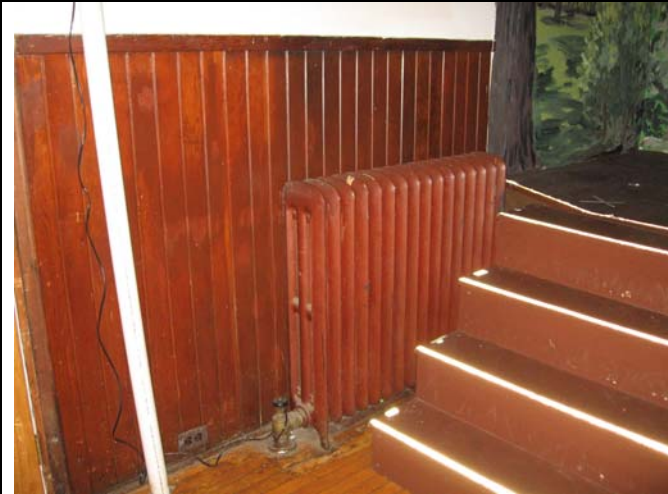
Fig. H-5- Steam radiator.

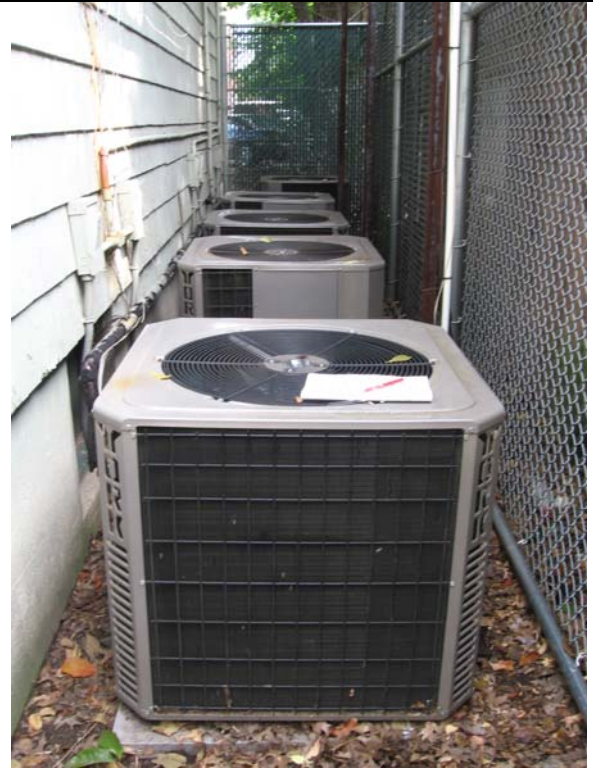
The Parish Hall is cooled by two split system direct expansion units. The condensing units are located outdoors behind the Parish Hall stage (*Fig. H-6*). The evaporator coils are located outdoors downstream of the fan section (*Fig. H-7*). Air is distributed to the space via exposed ductwork (*Fig. H-8*)

Cooling- No problems have been noted concerning cooling in the Sanctuary and Parish Hall. The equipment is approximately 5 years old and appears to be in good condition.

Fig. H-6- Condensing units

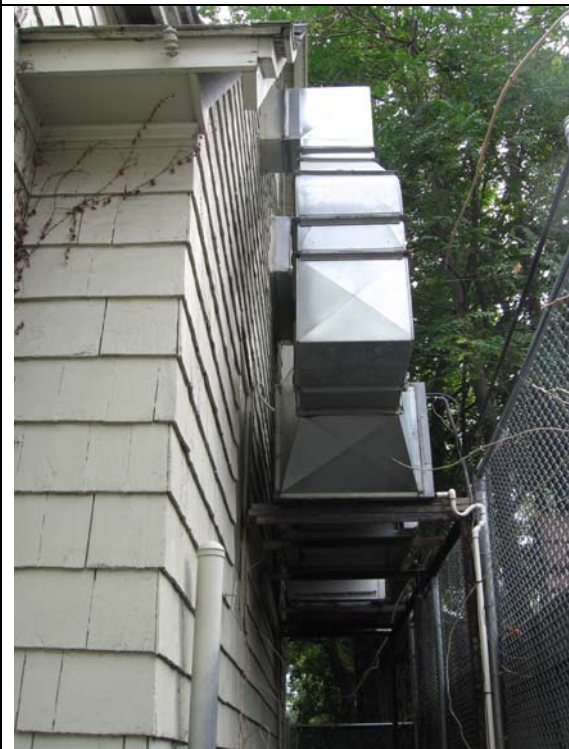
Fig. H-7- Parish Hall air handling units.

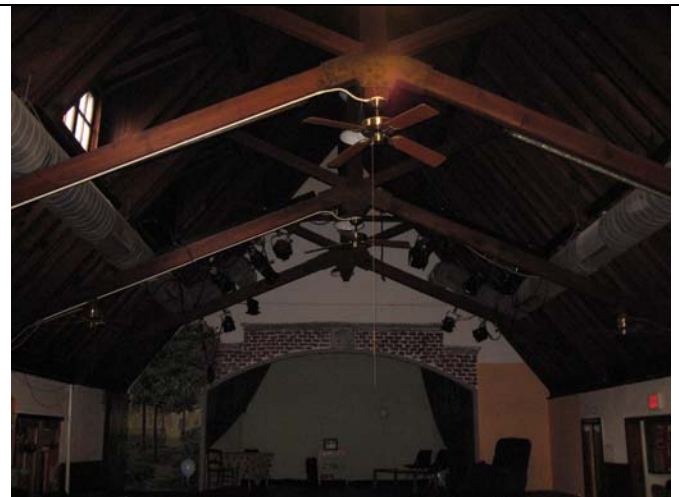
The diffusers in the exposed ductwork in the Parish Hall are said to provide poor air circulation in heating mode since they are oriented horizontally and do not force the warm air down to ground level.

Fig. H-8- Parish Hall ductwork

Rotate the supply registers in the Parish Hall ductwork to better distribute warm air in the space.

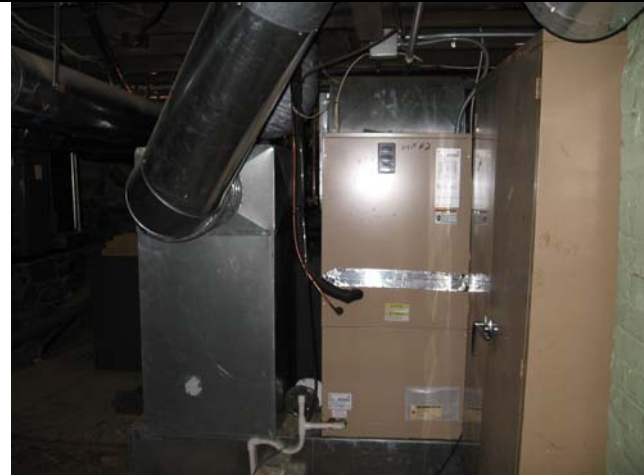
The Sanctuary is cooled by three split system direct expansion units with outdoor evaporators located behind the Stage (*Fig. H-6*) and indoor blower coils in the basement (*Fig. H-9*). These units are ducted to floor supply and return grilles in the Sanctuary (*Fig. H-10*).

Fig. H-9- Sanctuary air handling unit.

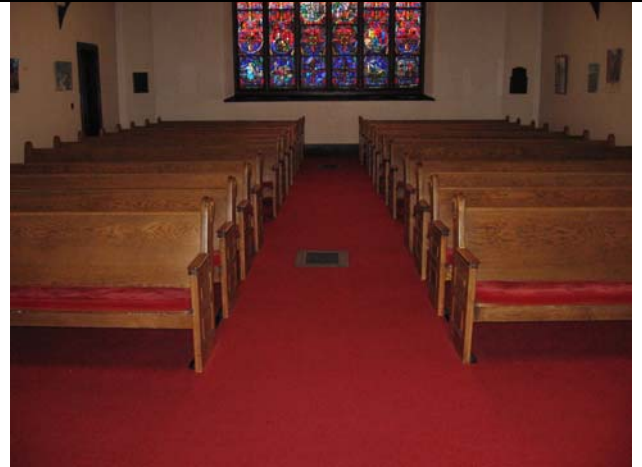
Fig. H-10- Sanctuary floor grille.

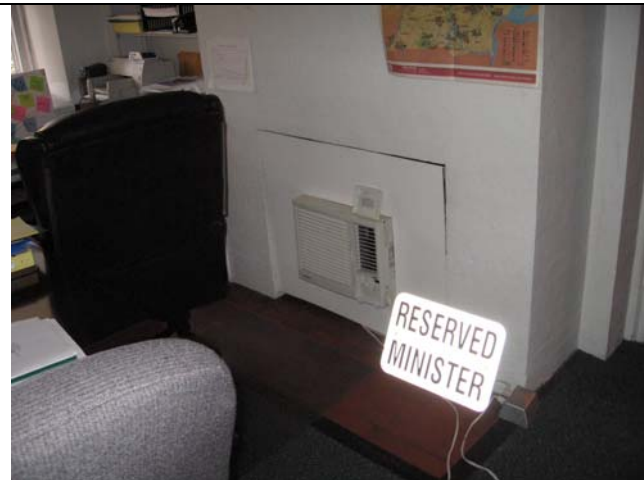
The ministers office is cooled by a window type air conditioning unit which vents into a fireplace (*Fig. H-11*).

The Ministers Office is cooled by a window type cooling unit vented into the chimney which is not an acceptable installation.

Fig. H-11- Ministers office cooling unit.

The heating for the Ministers office should be arranged to allow for its own zone of control. The window air conditioning unit installed in the fireplace should be removed and replaced with a small split system heat pump unit which would provide both heating and cooling.

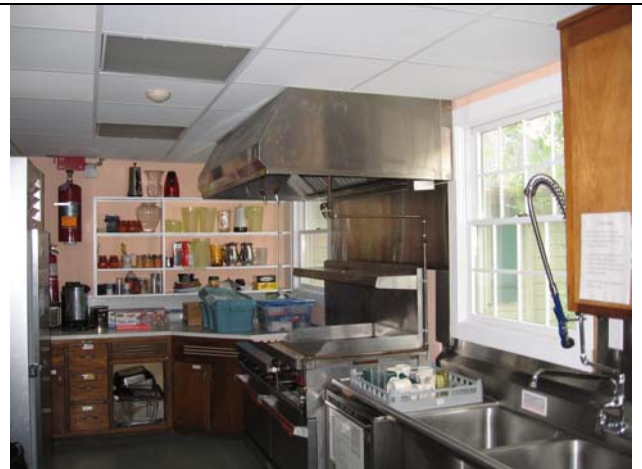
The kitchen is provided with a commercial type exhaust hood with fire suppression (*Fig. H-12*). The kitchen exhaust fan is located on the roof above (*Fig. H-13*).

Fig. H-12- Kitchen exhaust hood.

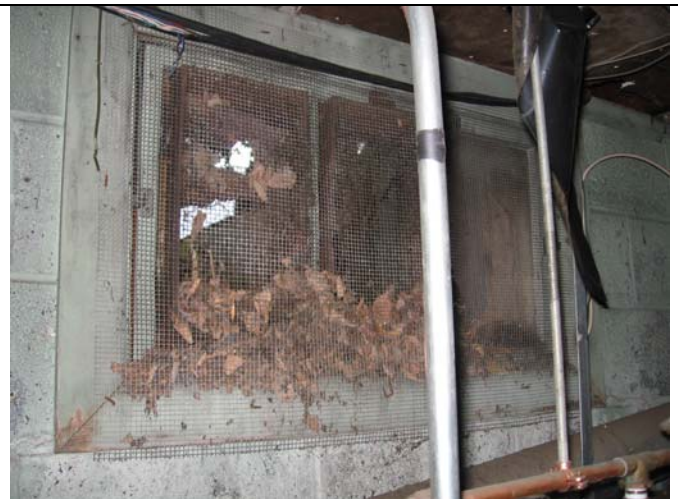
Combustion air is provided for the hydronic boilers by an open basement window (*Fig. H-14*). Combustion air for the steam boiler is provided by infiltration.

Ventilation- The combustion air opening for the hydronic boilers does not meet current code requirements. The screened opening was partially clogged with leaves at the time of our visit, further restricting fresh air flow. Insufficient combustion air may cause carbon monoxide production.

Fig. H-14- Boiler room combustion air opening.

The combustion air supply for the school boilers should be upgraded to conform with current code requirements. This would either be via two openings in the outside wall with motorized dampers or a supply air fan interlocked with each boiler.

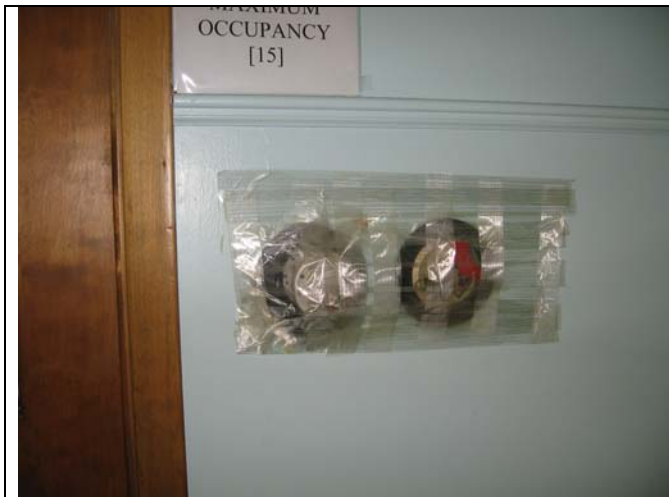
The thermostats which control the heating system in the school wing are manual type without automatic time clock control. Several thermostats were missing components at the time of the survey (*Fig. H-15*).

Fig. H-15- Damaged school wing thermostats.

Replace the heating system controls for the classrooms with systems which allow for automatic setback such as local time clock digital thermostats. We are told that replacement of these thermostats with time clock type units is in progress.

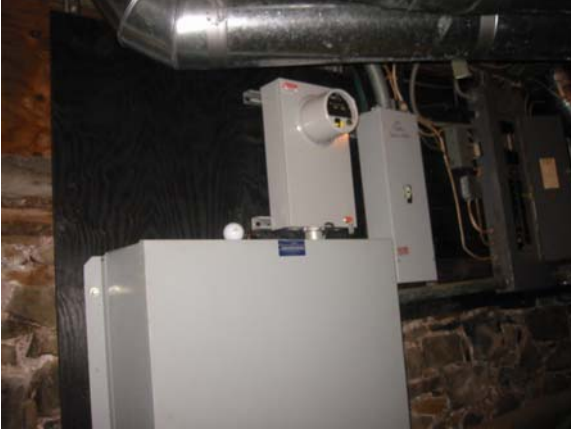
Service- The electric service is located in the basement under the sanctuary (*Fig. E-1*) The service is a two pole service providing 120/240 volts. The electrical meter and current transformer cabinet are located at the service entry point.

Fig. E1- Service Meter, CT Cabinet and AC Disconnect

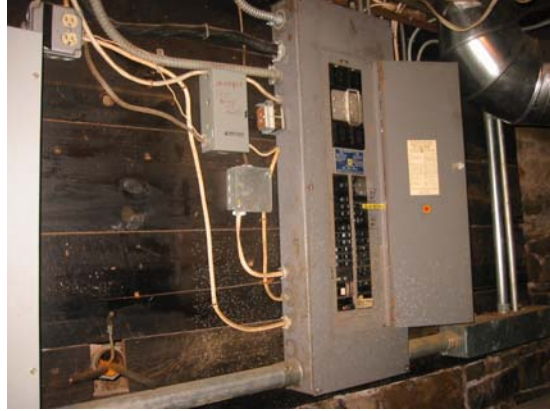
The original service was replaced as part of an HVAC upgrade. The original service was disconnected from the main service panel (MSP). The MSP was reconnected to the new service. This panel is a 40 pole, 200 ampere, Square D panel with a pull out main disconnect. (*Fig. E-2*)

Fig. E2 –Main Service Panelboard (MSP)

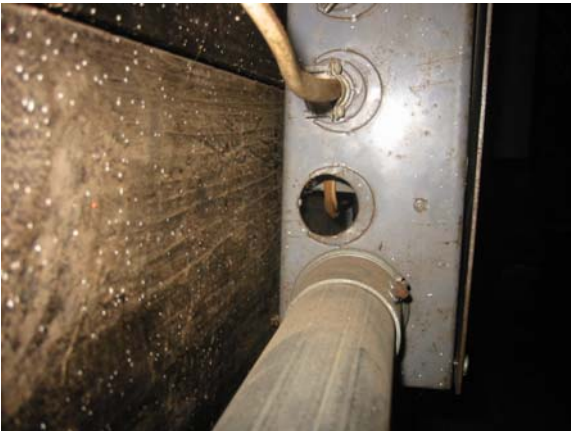
Distribution- The MSP contains the distribution circuit breakers for the electrical panels located throughout the building. There is an open knockout in the side of the panel that should be sealed. (*Fig. E-3*)

Fig. E3- Open knockout in MSP

Service- The electric service is adequate for the current usage of the building. The size of the service will have to be reviewed if air conditioning is added to the building. The knockout should be sealed in panel MSP.

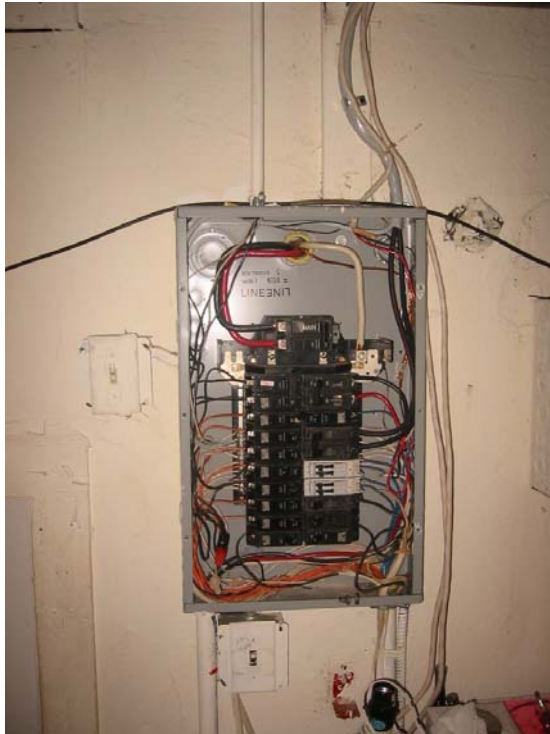
A 100 ampere, 2 pole circuit breaker serves the stage panel. This panel is a 100 ampere, 20 pole panel manufactured by GE. (*Fig. E-4*)

Fig. E4- Stage Panel

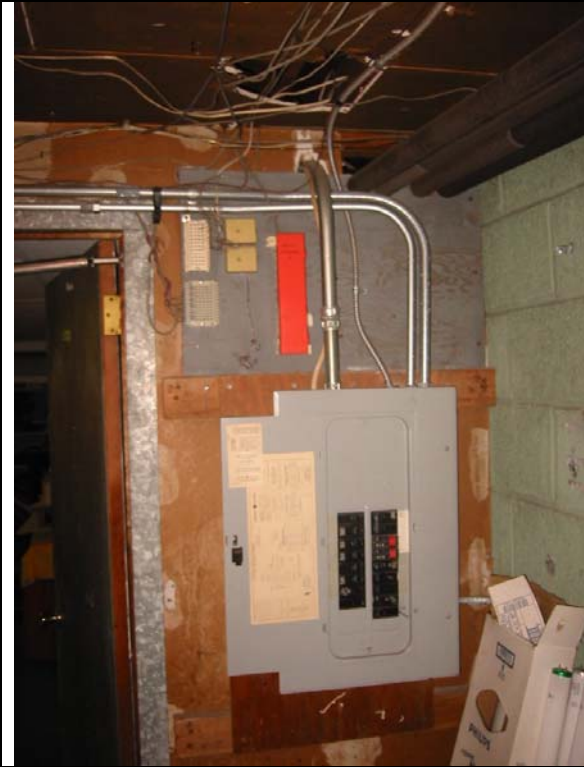
A 100 ampere, 2 pole circuit breaker serves the panel in the Steven's boiler room. This panel is a 125 ampere, 24 pole, load center. (*Fig. E-5*)

Fig. E5 – Boiler Room Panel –School Wing

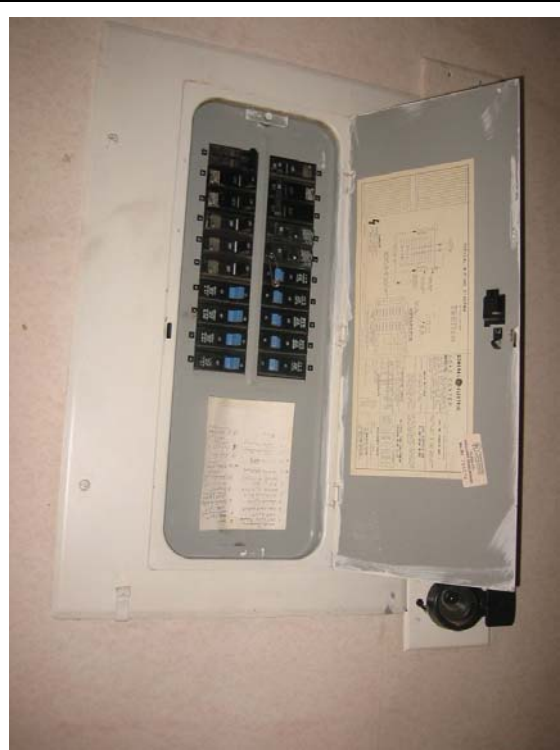
A 100 ampere, 2 pole circuit breaker serves the panel in the entrance vestibule near the kitchen. This panel is a 125 ampere, 24 pole, GE load center. (*Fig. E-6*)

Fig. E6 – Entrance Panel

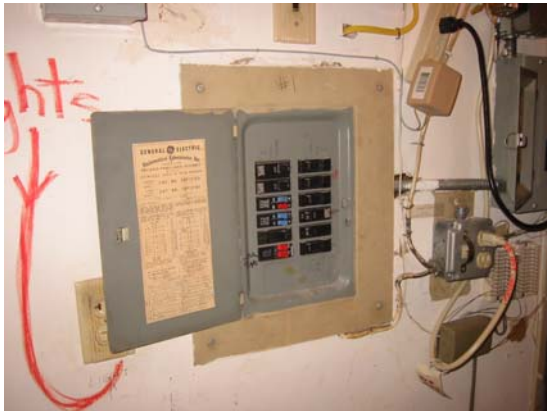
A 60 ampere, 2 pole circuit breaker serves the panel in the Steven's first floor closet. This panel is a 60 ampere, 12 pole, GE load center. The load center appears too small for this area. (*Fig. E-7*)

Fig. E7 – School Wing Closet Panel

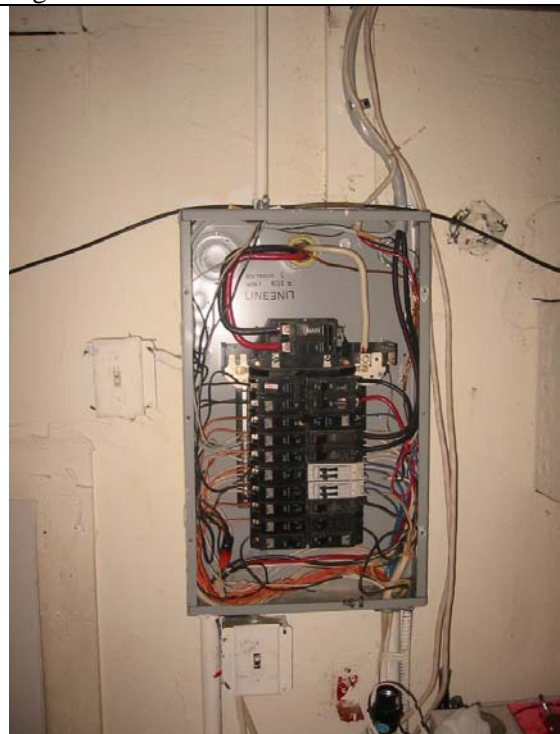
Non-metallic jacketed wiring (NM cable) is not permitted for use in non-residential building unless concealed by a 15 minute fire rated assembly. There is a significant amount of this type of cable installed exposed in the building. (*Fig. E-8*)

Fig. E8 – NM Wiring

Wiring- All older wiring should be replaced. All non-metallic jacketed wiring should be replaced.

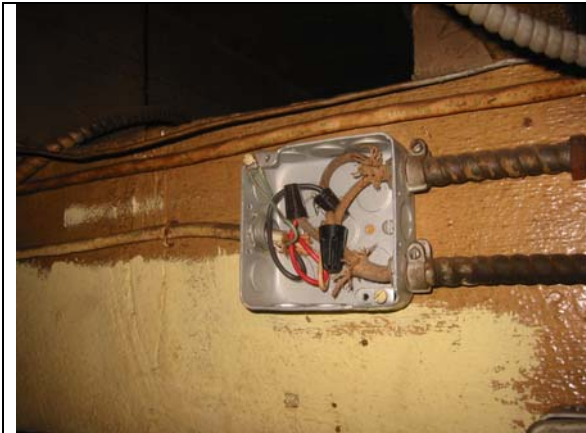
The majority of the wiring the Sanctuary wing is older style cable. (*Fig. E-9*)

Fig. E9 – Old Wiring in Sanctuary Basement

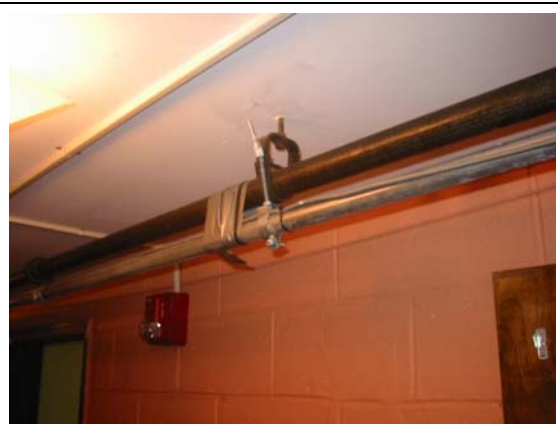
A conduit is attached to a gas pipe in the basement and is a code violation. (*Fig. E-10*)

Fig. E10 – Conduit attached to Gas Pipe

Natural Gas- A 1-1/4" natural gas service is stubbed into the sanctuary basement from Park Avenue to (2) gas meters (*Fig. P-1*). The natural gas serves the boilers, water heaters, and kitchen stove. In the classroom wing electrical conduit is hung from natural gas piping by duct tape.

Natural Gas- Service appears to be adequate. However, any proposed changes to the architectural layout, HVAC systems, and kitchen equipment must be reviewed to confirm adequacy. Electrical conduit should be properly re-hung independent of gas piping.

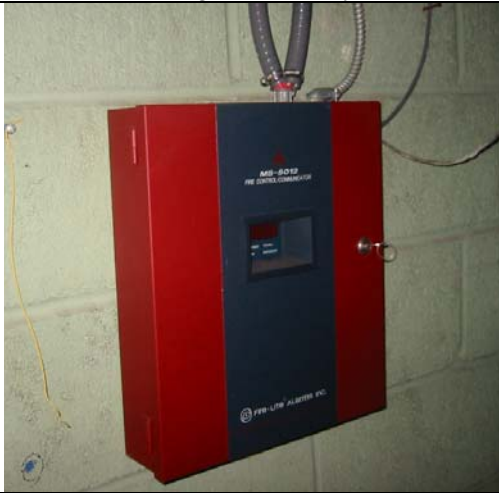
Fire Alarm System- The fire alarm system consists of Fire-Lite MS 5012 alarm panel with limited smoke detector coverage and manual pull stations. The smoke detector coverage is insufficient for proper protection of this building. (*Fig. E-11*)

Fig. E11 – Fire Alarm Panel

Fire Alarm System- A fire alarm and detection system should be expanded to cover the entire building adequately. Additional alarm devices should be added to the classrooms.

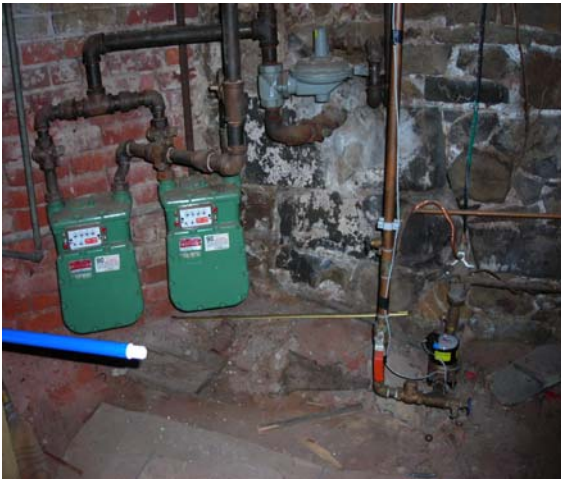
Domestic Cold Water- A 1" domestic water service enters the building in the basement from Park Avenue, equipped with a ½" water meter (*Fig. P-1*). The visible water distribution piping is copper.

Fig. P-1- Domestic Water & Natural Gas Services

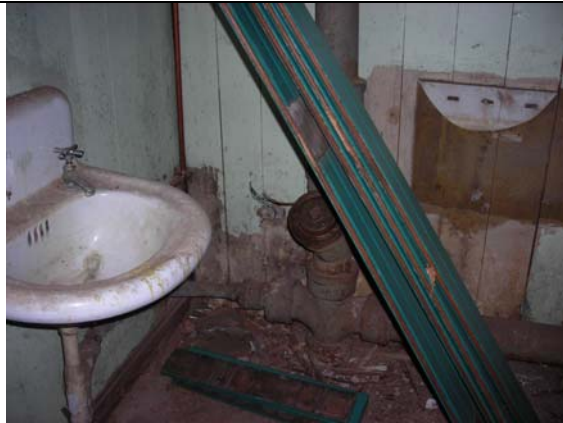
Sanitary Drainage- The sanitary system is made up of cast iron hub and spigot pipe. A 4 inch sanitary main exits the building below grade at the front of the sanctuary and discharges by gravity to the city sewer system at Park Avenue (*Fig. P-2*). A second 4 inch sanitary main exits the building at the back of the classroom wing below grade and discharge by gravity to the city sewer system (*Fig. P-12*).

Fig. P-2- Sanitary Service Exit To Park Ave

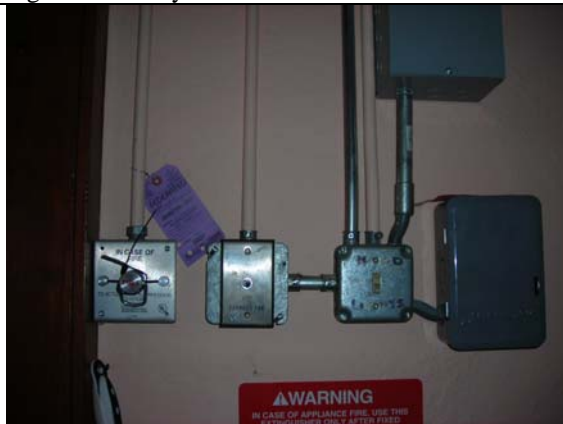
Fire Suppression- The fire suppression system consists of (2) limited area sprinkler heads in the boiler room. A chemical fire suppression system is provided for the grease exhaust hood located in the kitchen (*Fig. P-4, P-5*). The remainder of the building is not equipped with a fire suppression system. The attic space above the classroom wing is being used for combustible storage; this use is not code compliant since there appears to be neither a fire suppression system nor a 1-hour fire separation in this area.

Fig. P-4- Exhaust Hood Controls & Pull Station

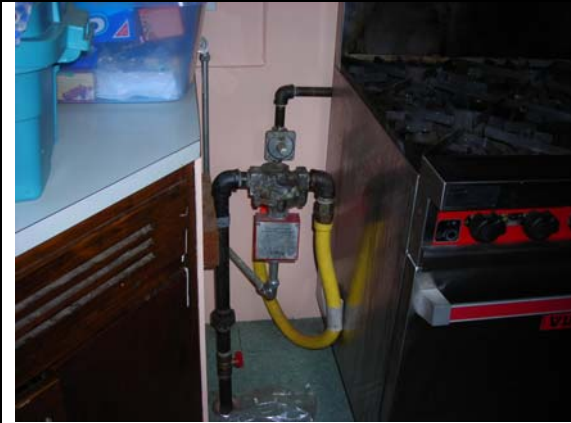
Fig. P-5- Gas Solenoid Valve To Range

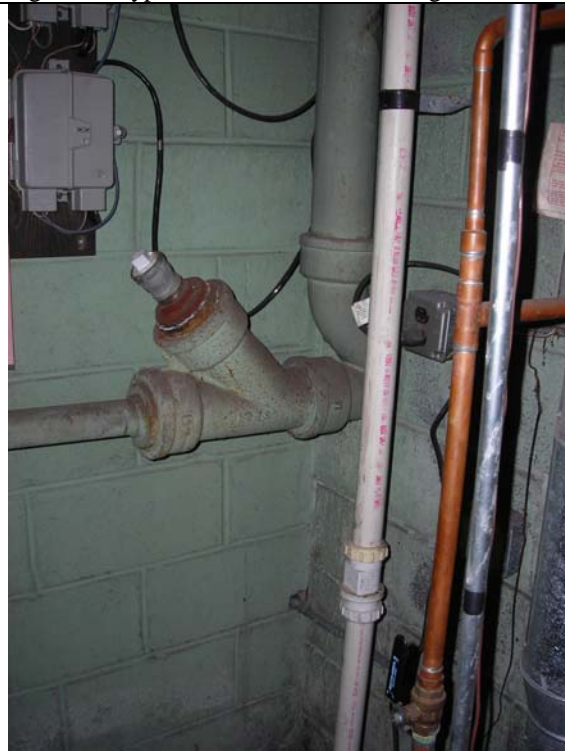
Fig. P-12- Sanitary Service Entrance In Classroom Wing

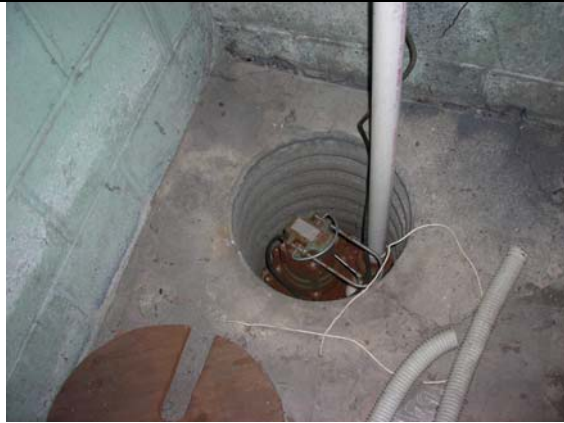
Fig. P-13- Sump Pit In Classroom Wing

The existing sump pump in the basement should be inspected to verify it is in proper working order and if necessary replaced with new. It may be beneficial to provide the sump pump with an emergency battery back-up power supply as suggested in the Building Needs Planning Committee Report – April 2007 this system could be applied with a new or existing pump.

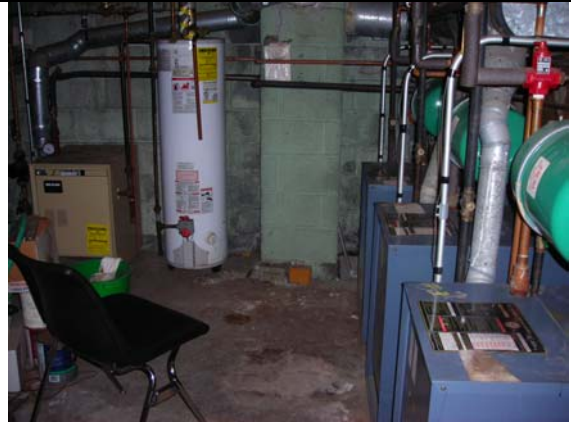
Domestic Hot Water- Hot water is provided by (2) gas fired hot water heaters. The first water heater serves the kitchen and toilet rooms at the sanctuary. This water is Rheem Model 44x40-2, 39 Gallon capacity, 57.7 MBH Natural Gas input (*Fig P-17*). The second water heater serves the classroom wing of the building. This water heater is GE Model GG30T6A, 30 Gallon capacity, 32 MBH Natural Gas input (*Fig. P-14*).

Fig. P-14- Water Heater in Boiler Room

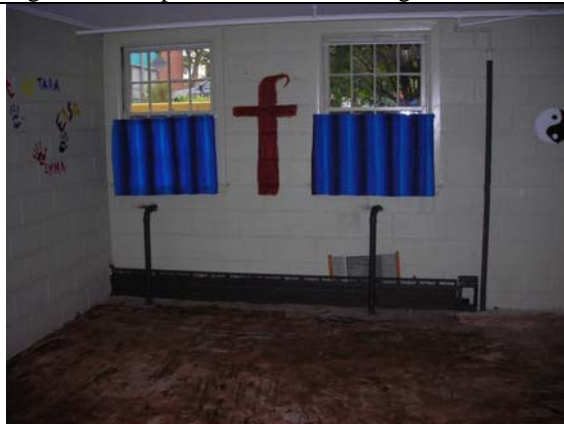
Storm Drainage- Storm drainage is comprised of outside gutters and downspouts discharging to grade (*Fig. P-18*). At the basement level, the window wells are each provided with a drain that runs through the basement (*Fig. P-15*).

Fig. P-15- Window Well Drains In Basement

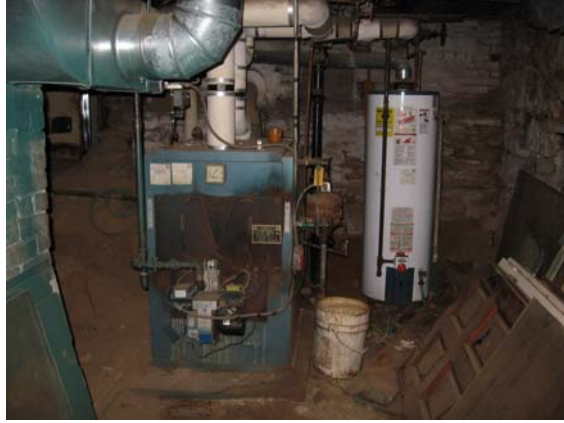
Fig. P-17- Water Heater & Steam Boiler

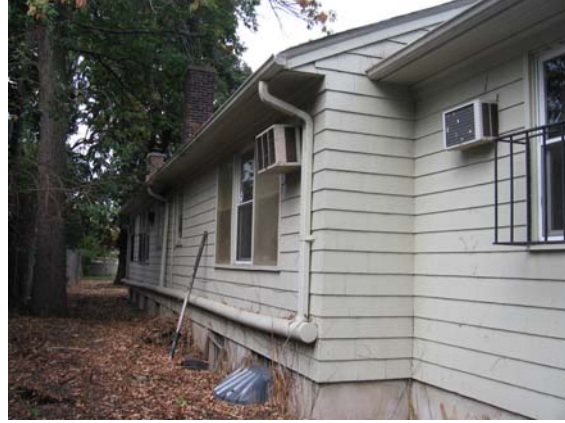
Storm Drainage- There are a few locations where the down spouts have been disconnected. Also there are some reported problems with storm water entering the basement.

Fig. P-18- Storm Drainage At Back Of Building

Storm Drainage- Where required reconnect and/or extend storm drainage away from building, replace worn and broken splash blocks, some minor site work may be required to insure the storm drainage flows away from the building. It was also suggested in the Building Needs Planning Committee Report – April 2007 to investigate connecting the building storm drainage to the city drainage system, evaluation of this item will require assistance from a civil engineer for the collection and routing of the storm drainage along with appropriate grading of the site.
